Berko Electric Toe-Space Heaters Recalled Due to Fire Hazard

IMPORTANT SAFETY RECALL NOTICE – RISK OF FIRE – ACTION REQUIRED

Berko Electric / Marley Engineered Products Toe-Space Heater Recall

HOW TO CHECK YOUR HEATER

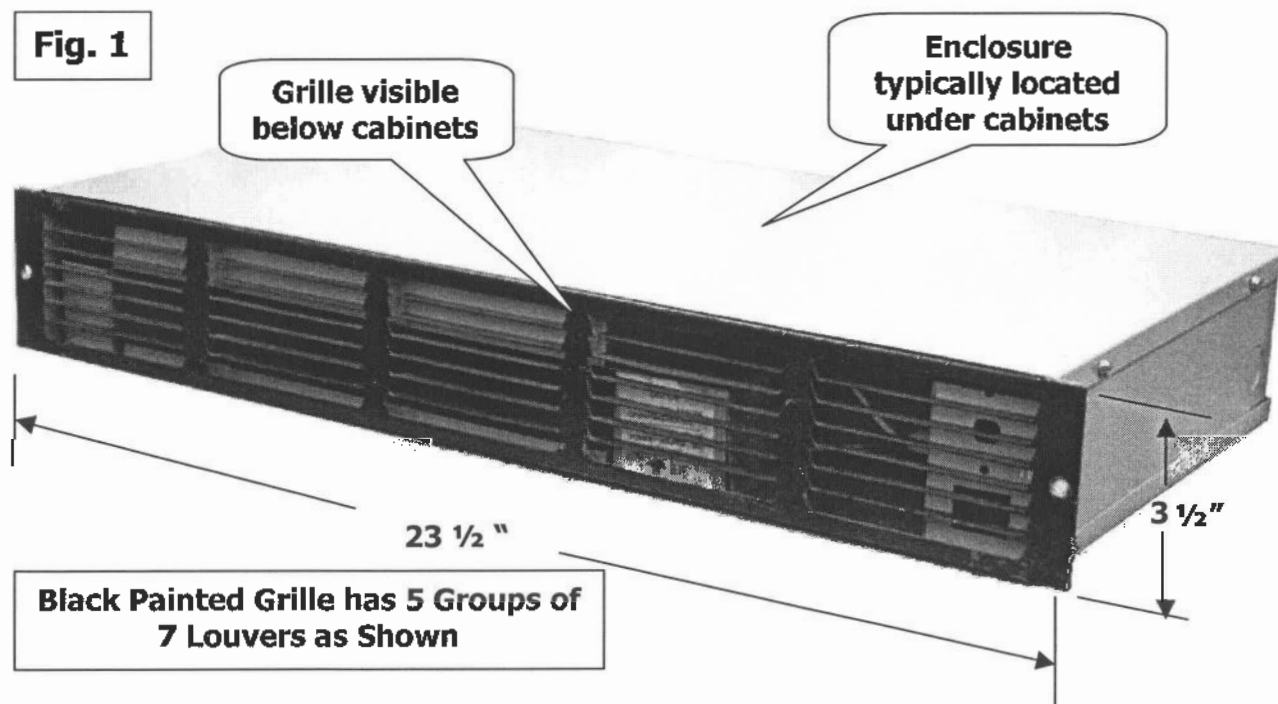
To determine if you have an affected heater, first check the heater grille to determine if it looks like the one pictured and measures approximately 23-1/2" wide by 3-1/2" tall (see Fig. 1). If it looks like the picture and measures the correct size, proceed to STEP 2, otherwise, the heater is not one affected by this recall.

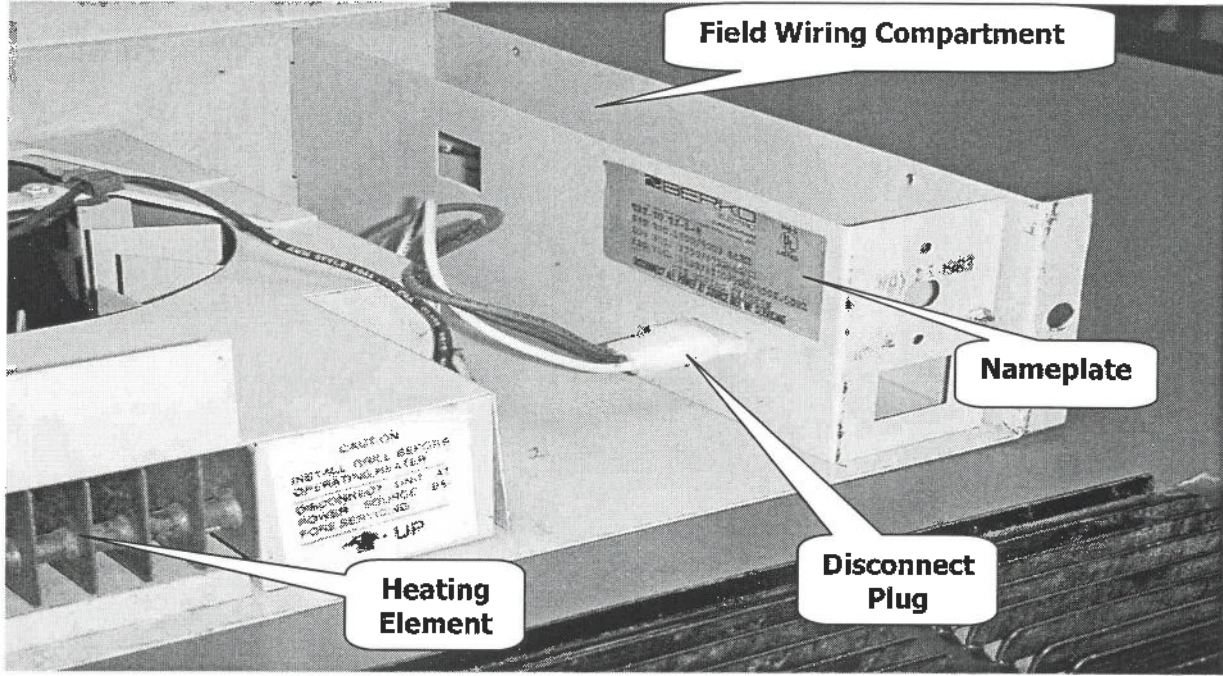
Fig. 2

If the grille is as shown, next you will need to look inside the heater to check the heater nameplate as shown in Fig. 2. It will probably be necessary to remove the grille to see clearly, although the nameplate may be visible by looking through the grille. Be sure power to heater is OFF before removing the grille. If the nameplate shows the heater is one of the affected models, proceed to STEP 3.

Heater Interior (With Grille and Top of Enclosure Removed for Clarity)

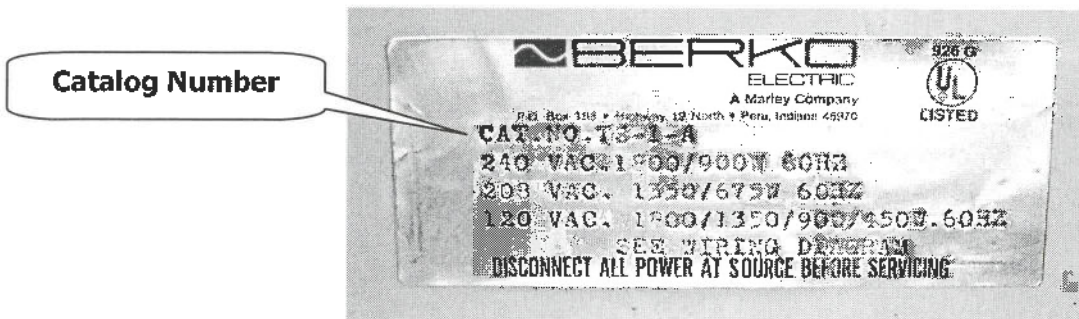
- Berko Electric Cat. Nos. **TS, TS-1 and TS-1-A** which do not have a thermal fuse
- Emerson Cat. No. **KSH 2000** which does not have a thermal fuse
- Typical Berko Nameplate Photo:

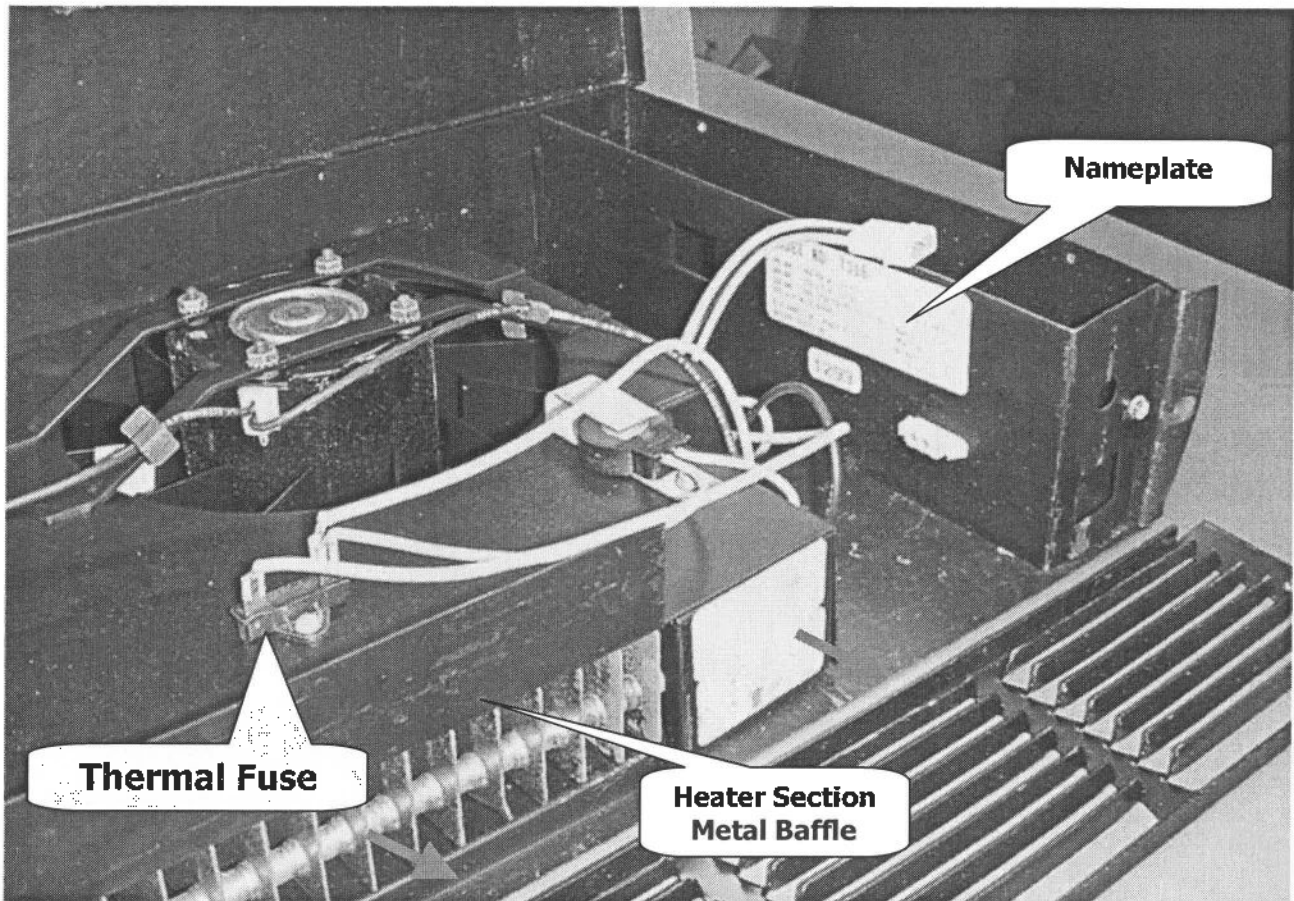
Fig. 3

Newer models built after February 15, 1985 include a back-up thermal fuse. Check to see if your heater has the thermal fuse as shown. If your heater has the thermal fuse, the heater is NOT affected by this recall. If it does not have the thermal fuse, proceed to WHAT TO DO IF I HAVE AN AFFECTED HEATER.

Newer Berko Toe-Space Heater With Thermal Fuse

(NOT INCLUDED IN THE DISCOUNT REPLACEMENT PROGRAM)

Note: To confirm if your heater has the thermal fuse may require that you slide the heater section out of the enclosure slightly so you can see since the fuse will be located behind the metal baffle.

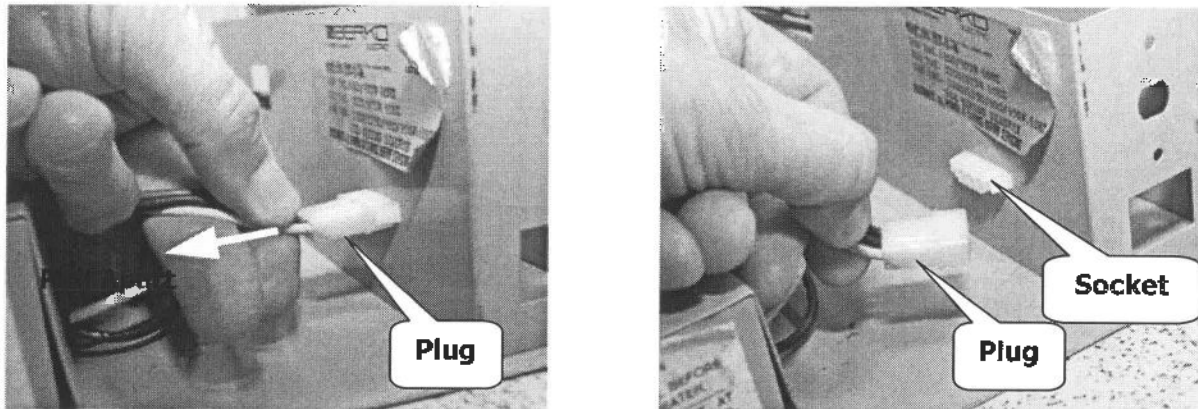
To unplug the heater, disconnect the heater plug from the heater socket as shown below.

STOP USING YOUR HEATER IMMEDIATELY AND UNPLUG THE HEATER SO IT CANNOT OPERATE

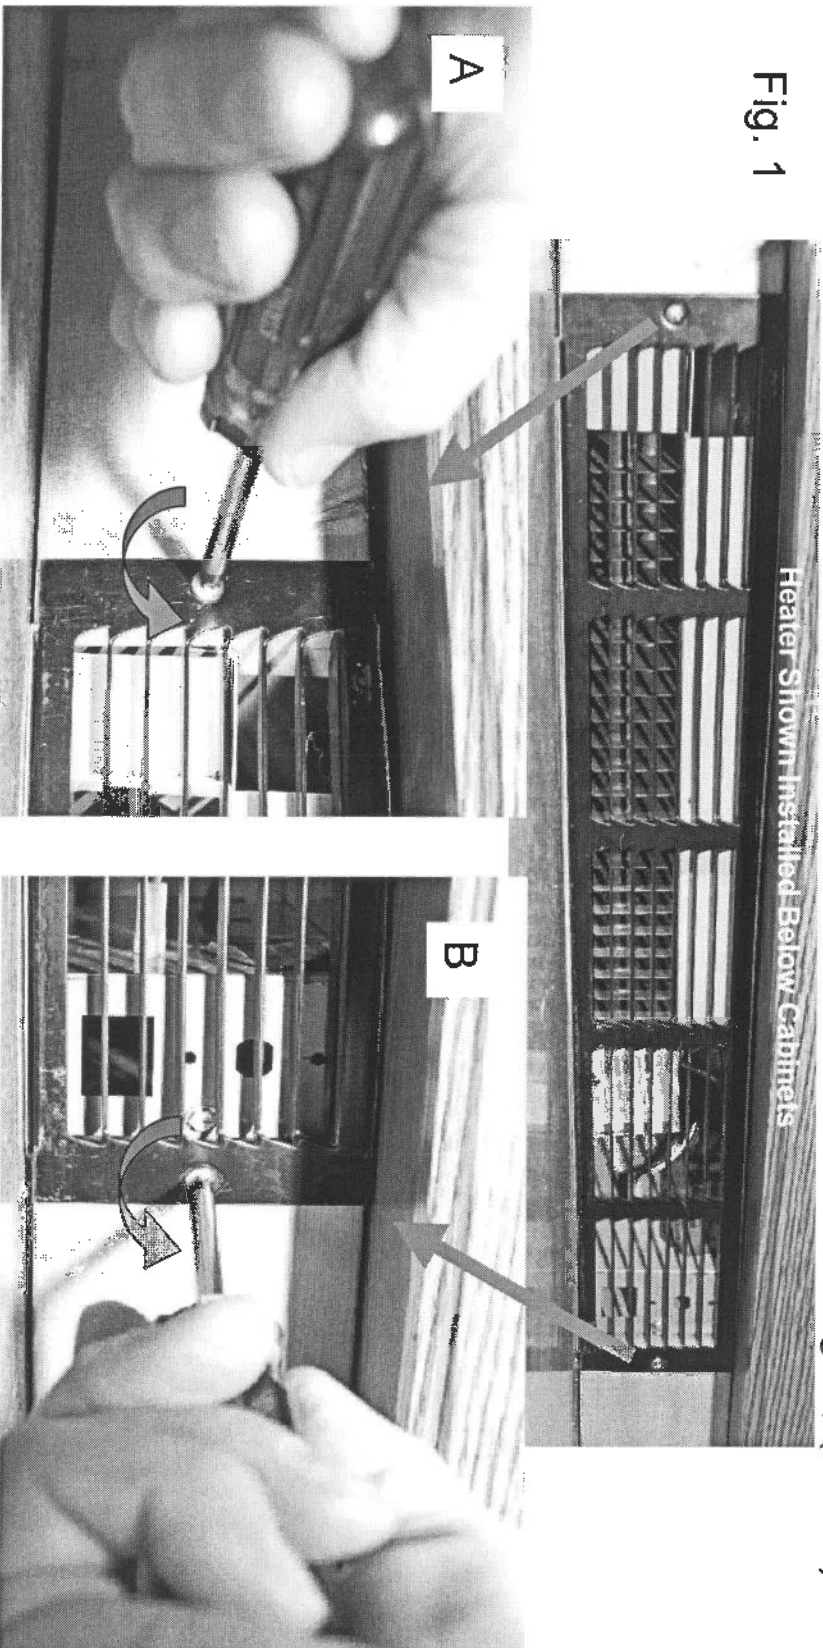
Fig. 1

Step 2. Remove Grille by removing the two screws as shown in Fig. 1, (A & B)

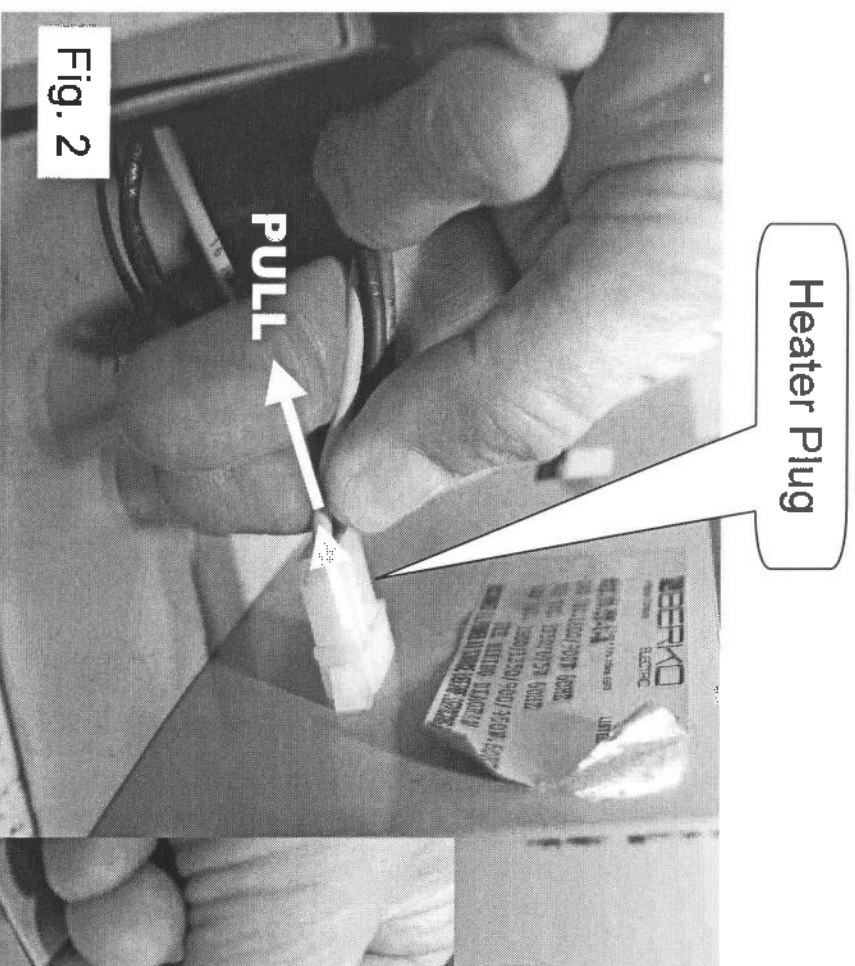
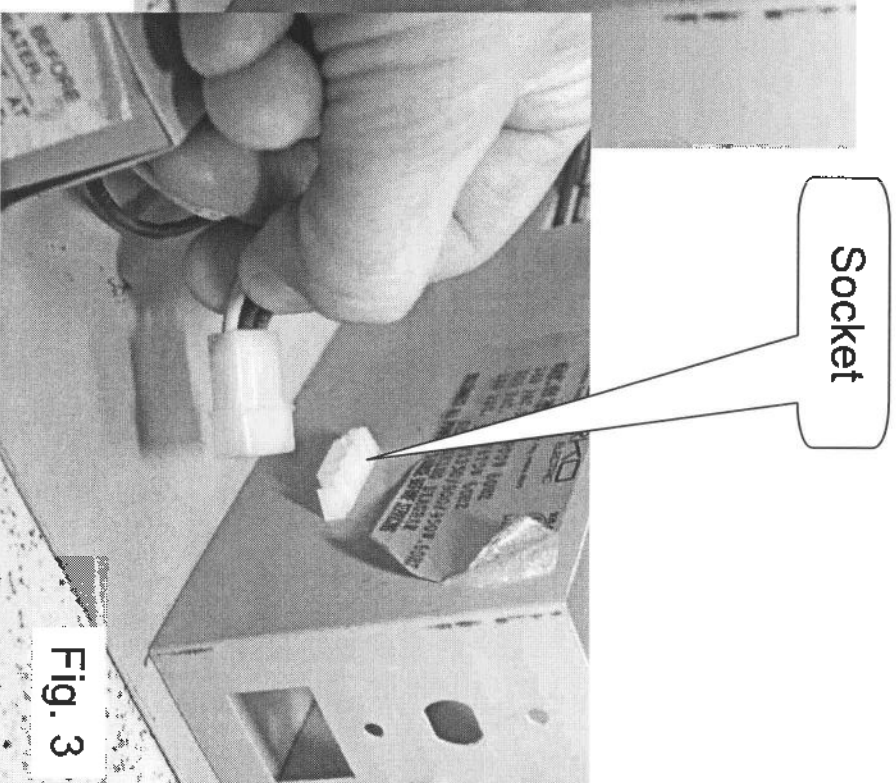
Step 3. Disconnect Heater Plug From Socket By Pulling Apart (See Figs. 2 & 3)
(Grille and Enclosure Top Cover Removed for Clarity)

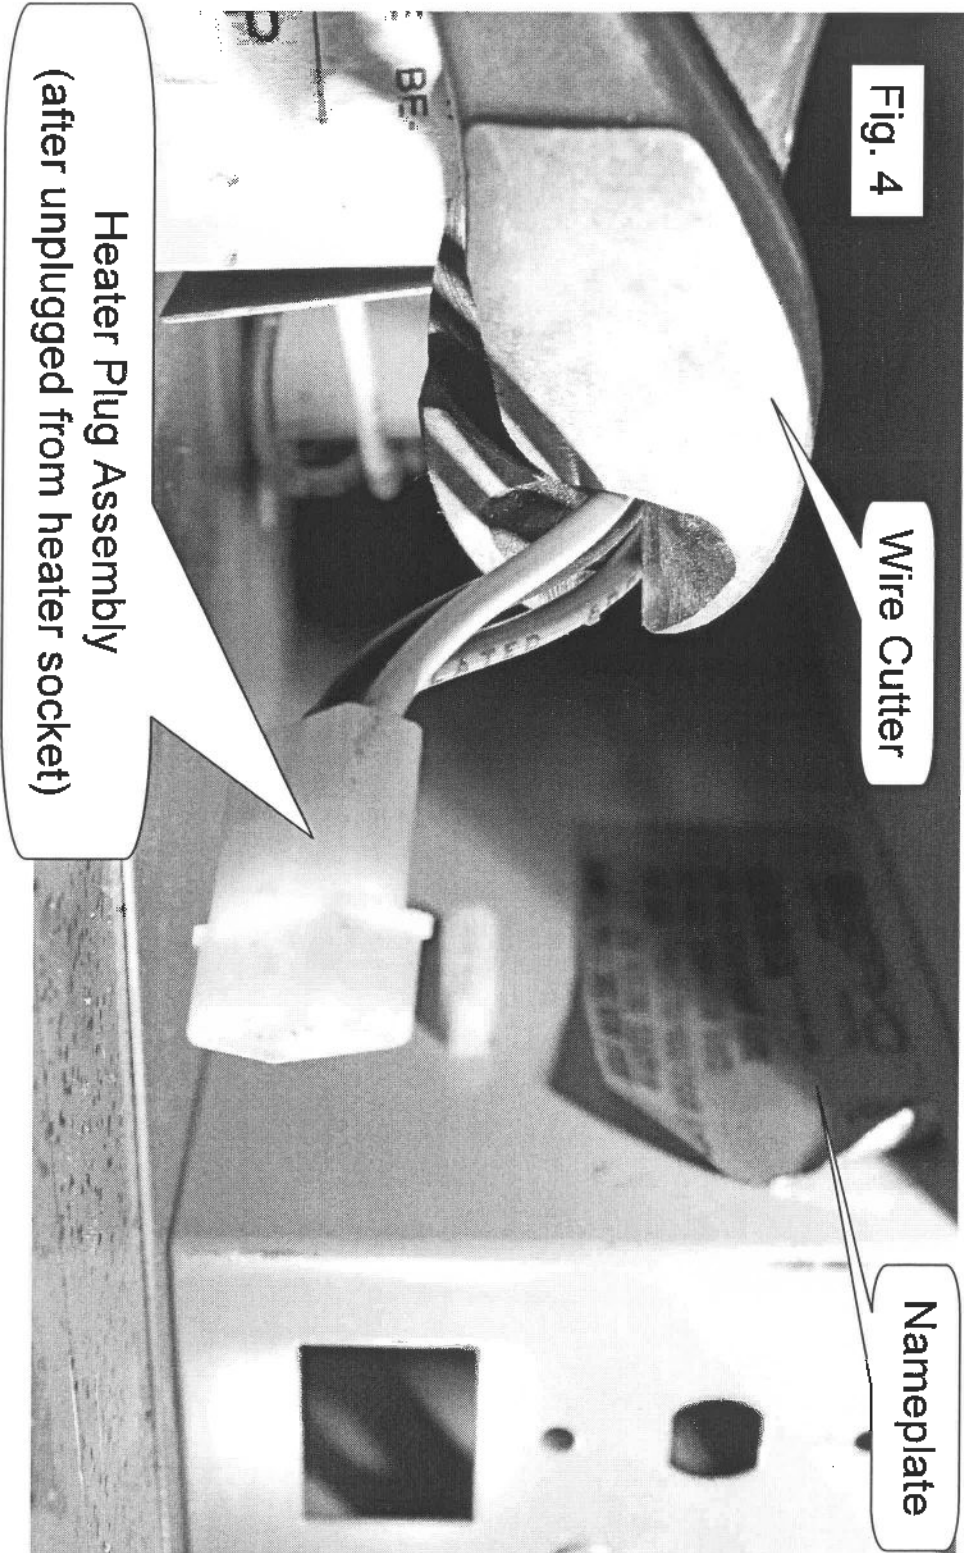
Fig. 4

Step 4. Cut Wires and Remove Heater Plug Assembly As Shown (See Fig. 4)

**Heater Plug Assembly
(after unplugged from heater socket)**

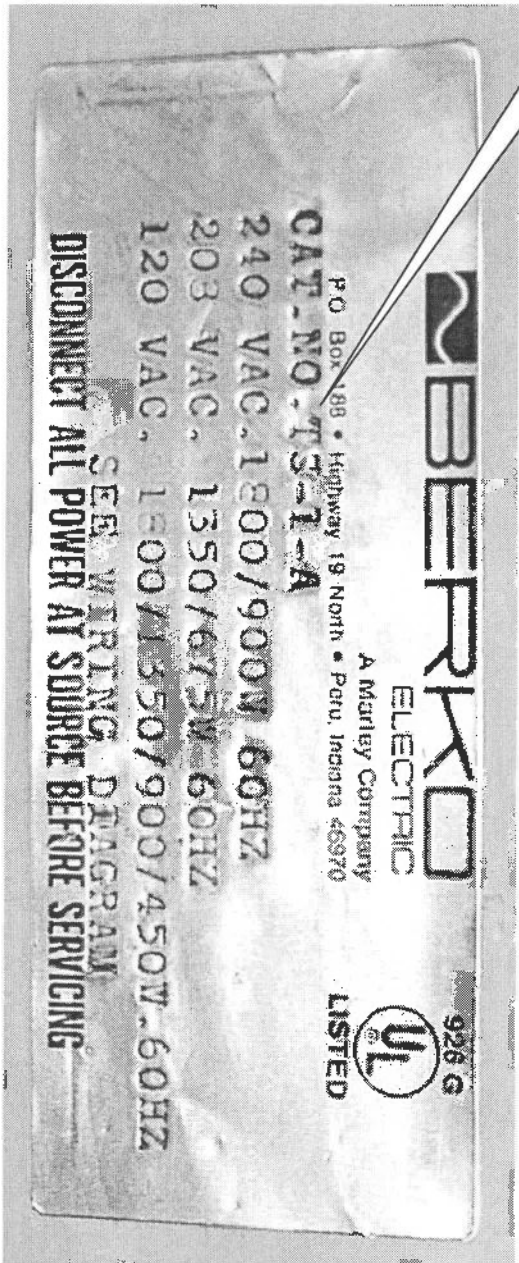
Step 5. Record the Heater Catalog Number from Nameplate Label (Fig 5) and Complete Customer Information Form

Fig. 5 Berko Nameplate Label
(Located Adjacent To Plug And Socket)

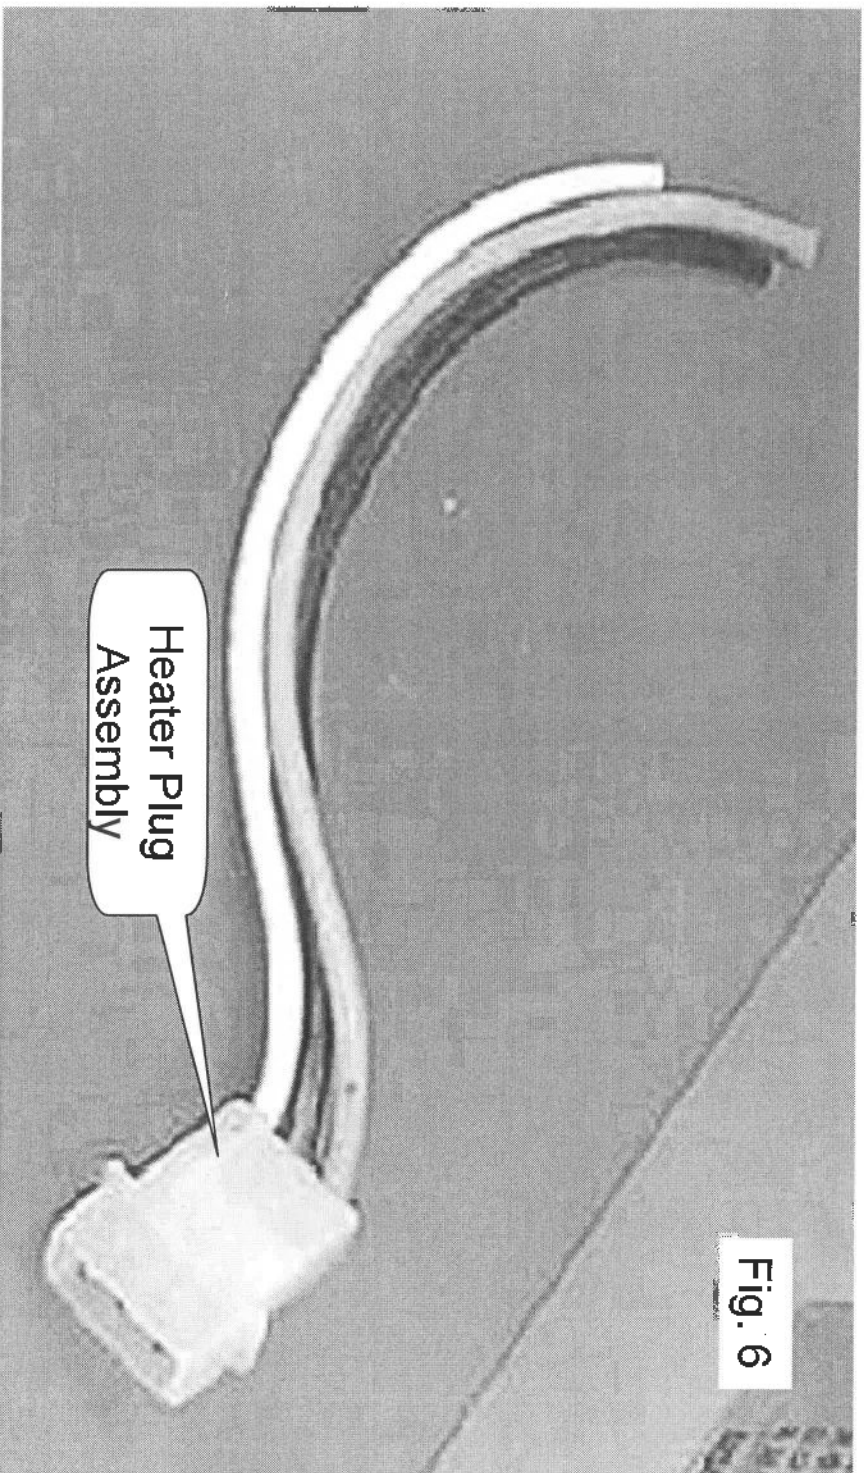
Step 6. Return Heater Plug Assembly (Fig 6) And Completed Customer Information Form to Factory for \$25 Rebate or Discount on Purchase of New Heater.

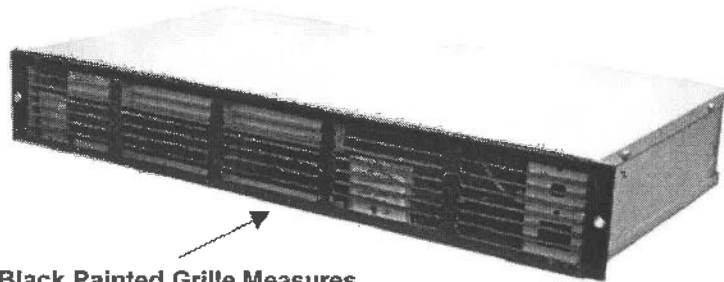
Black Painted Grille Measures
23-1/2" Long by 3-1/2" High

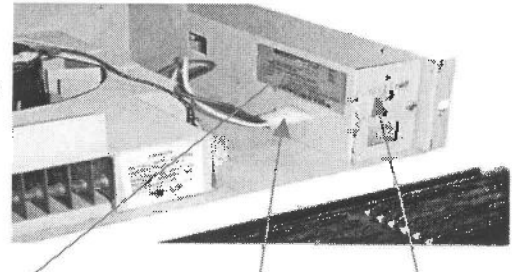
(Shown with grille and top enclosure removed)

Nameplate:
Berko Electric Cat. Nos.:
TS, TS-1 and TS-1-A, or
Emerson Cat. No.
KSH2000

Power
Plug

Date Code:
Before
February 15, 1985
